AMARILLO AIR TERMINAL BUILDING (Main Terminal and Terminal 30) aka:
Rick Husband Amarillo International Airport

Building Location: 10801 Airport Boulevard Amarillo, Texas

Date of Site Visit: 9/21/06

Field Notes, Background & General Observations

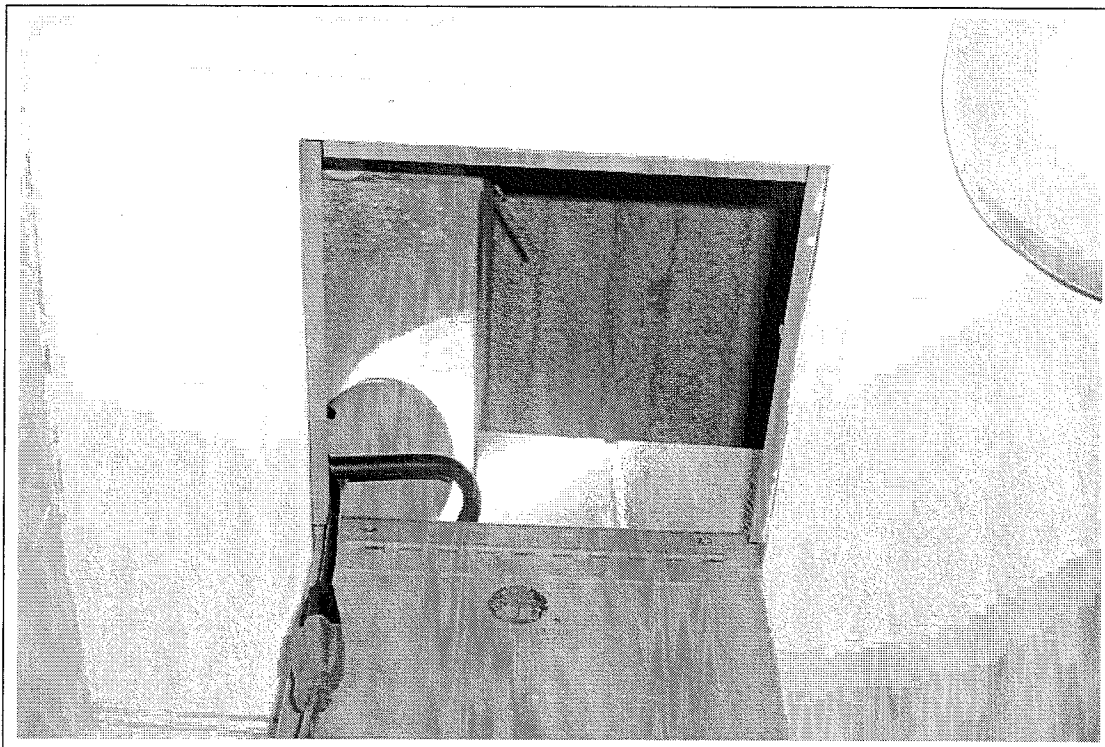
Photo 77. 10th floor, room 1003 - General view of fireproofed decking above plaster ceiling (thru access hatch)

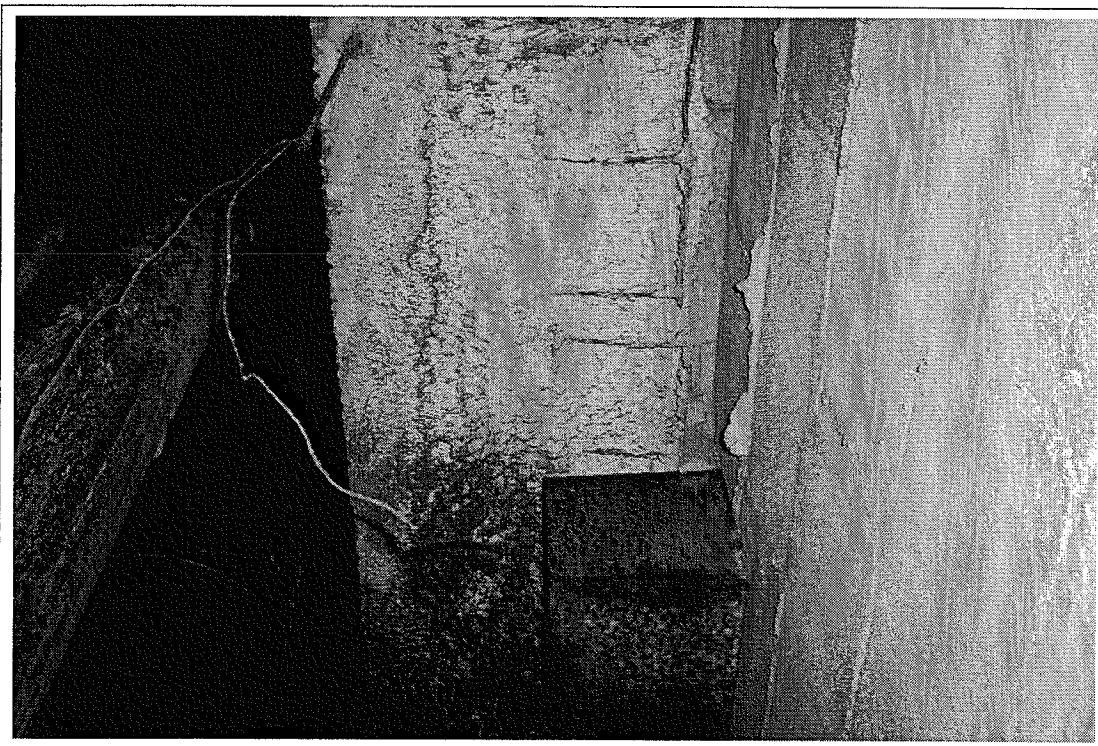
Photo 78. 5th floor, NE Fresh Air Shaft - View of fireproofing on concrete structure and black iron

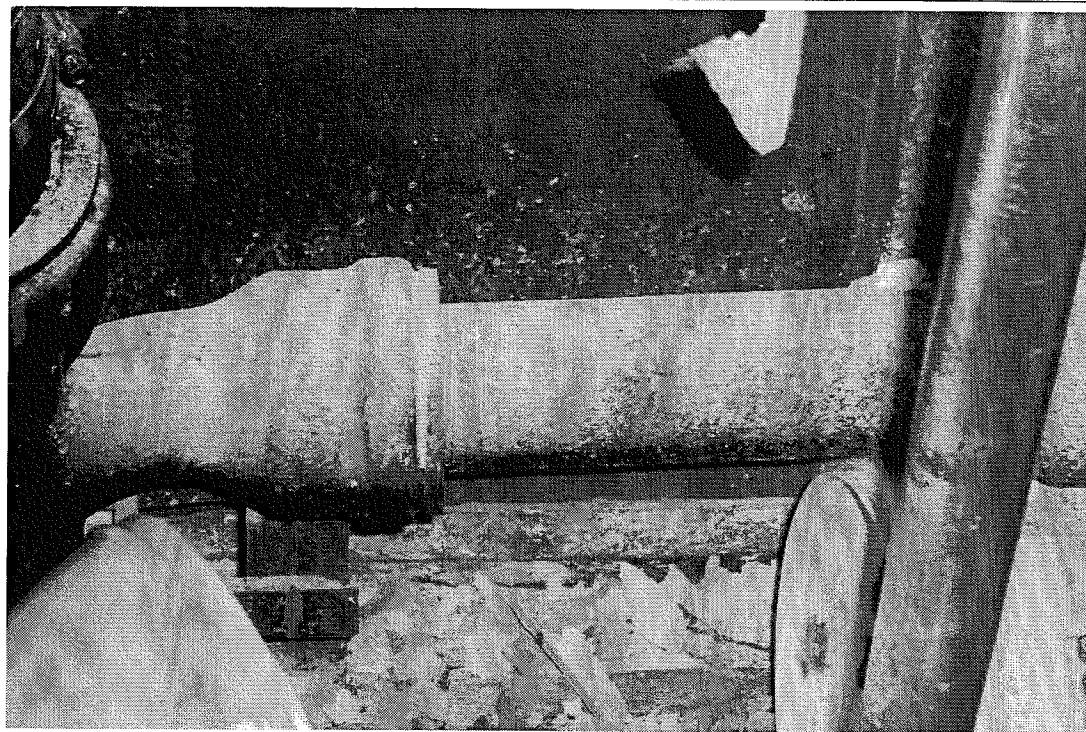
Photo 79. Annex 6th floor, adjacent to Women's RR - View of delaminated fireproofing dust and debris on iron pipe in wall (dust sample #2)

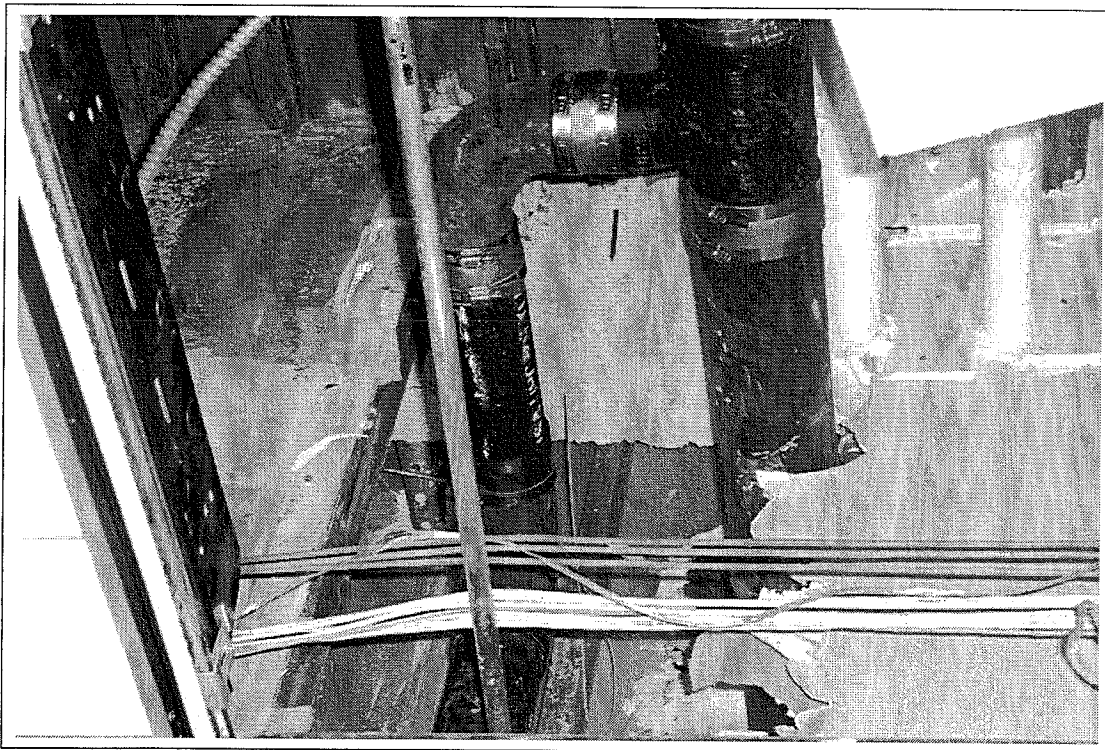
Photo 80. Annex 6th floor, adjacent to Women's RR - Close-up view of fireproofed beam above suspended ceiling and wall chase
